# Guidelines

for

## Maintenance of Aging Trike Wings

*September 2021*

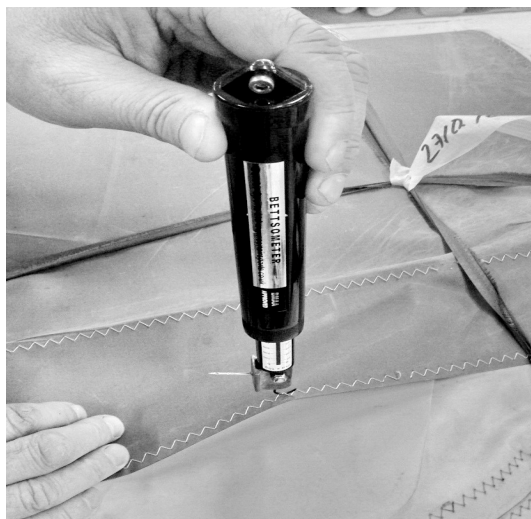
The sail requires special attention to the condition of the fabric, and Bettsometer tests will be required after significant amounts of environmental exposure to things such as UV radiation, chemicals and heat, as well as mechanical wear (and or tears).

Traditionally, top surfaces of trike wings are made from woven polyester sailcloth (Dacron). The strength of this sailcloth degrades over time, especially when exposed to sunlight (due to its high ultraviolet light content). The Betts test is devised to determine the condition of this kind of sailcloth. For Dacron fabric the default Betts test applies. Stitching on Dacron sail has to be tested with bettsometer to 1360 grams.
